Asbestos & Lead-based Paint Survey Report GSA Warehouse #1

WA0824KF

Auburn, Washington

April 1994

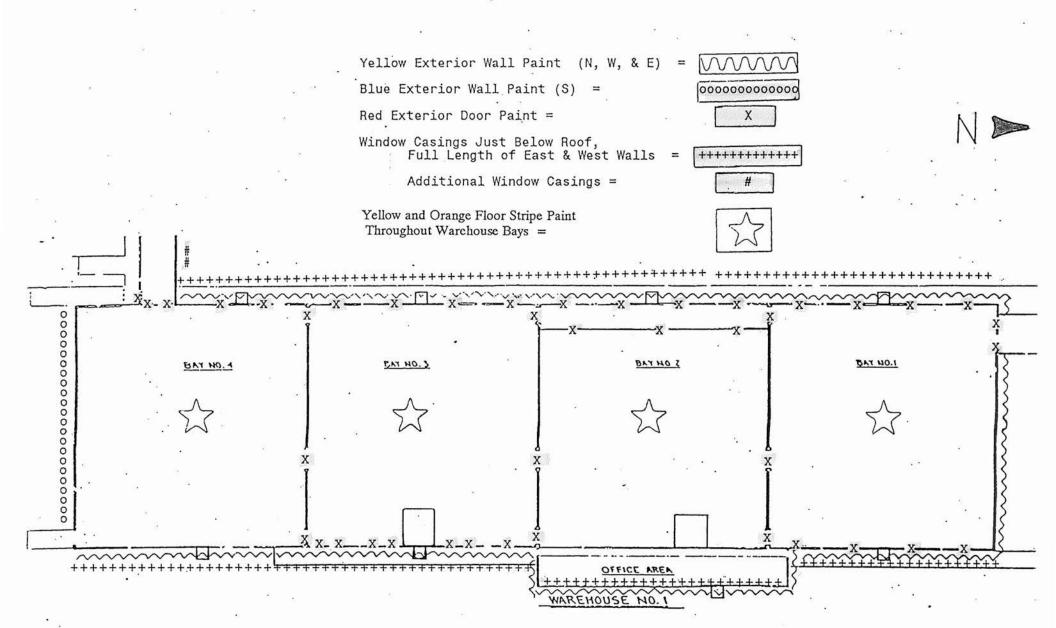
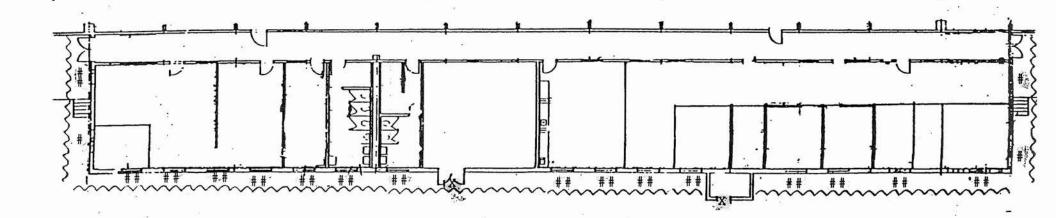
Location of Lead-Containing Materials Shown on Floor Plans

LEAD CONTAINING PAINTS

Yellow Exterior Wall Paint =
Red Exterior Door Paint =
Window Casings =
